**HIGHLAND FLATS TREE FARM
WETLAND AND RIPARIAN MITIGATION
-2017 ANNUAL REPORT-**

**Essential Oil Research Farm, LLC
Naples, Idaho 83847**

**EcoWest Consulting, Inc.
Baker, Oregon 97814**

December 2017

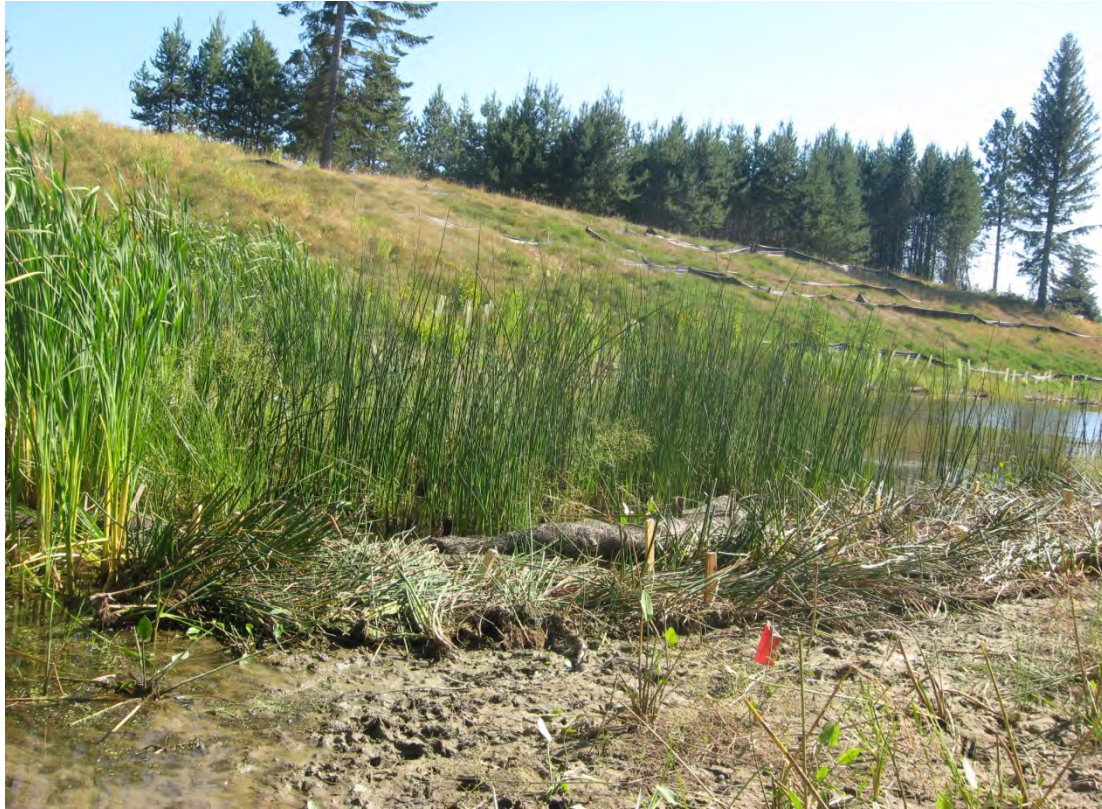
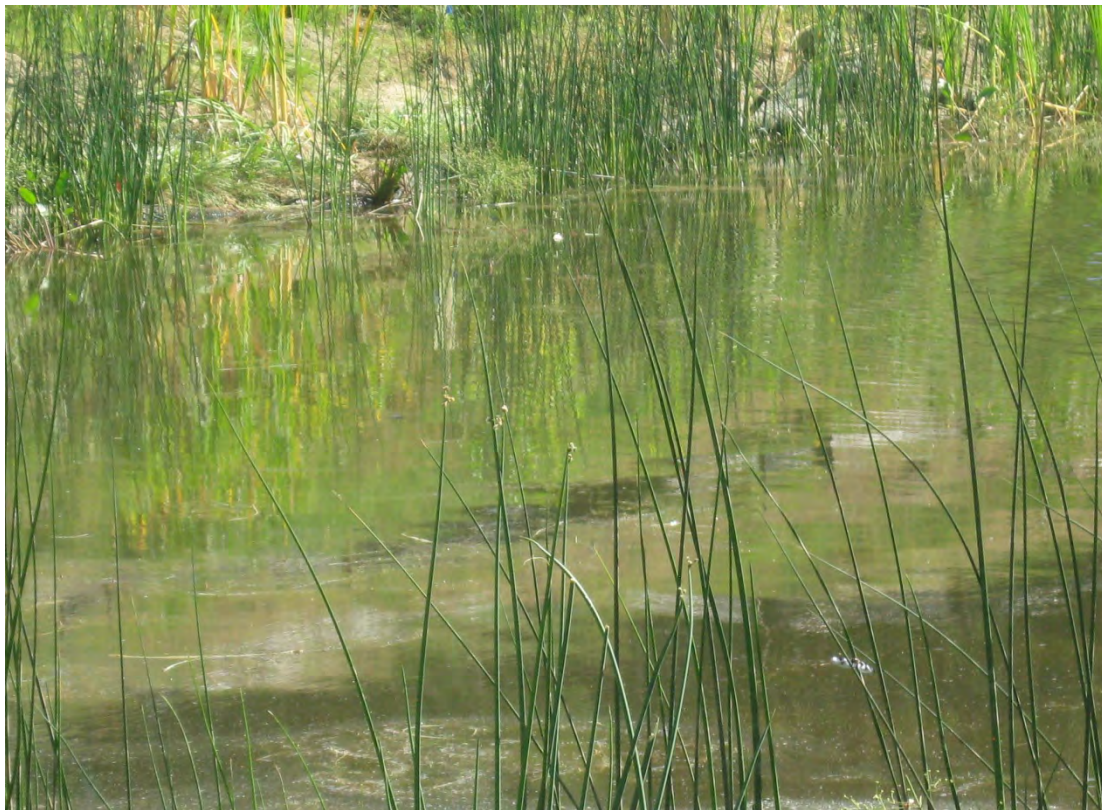
Figure D-9. Wetland sod from the western Reservoir margin near PP6 looking at both the 2016-installed bulrush sod in the background and the newly-installed sod in the foreground (top) and at the 2017-installed bulrush on both reservoir margins (bottom) in August 2017. Note the bulrush in flower in the bottom photograph.
